CASTRO VALLEY SANITARY DISTRICT

Wastewater Collection System Master Plan Update

MARCH 2016

WEST YOST ASSOCIATES

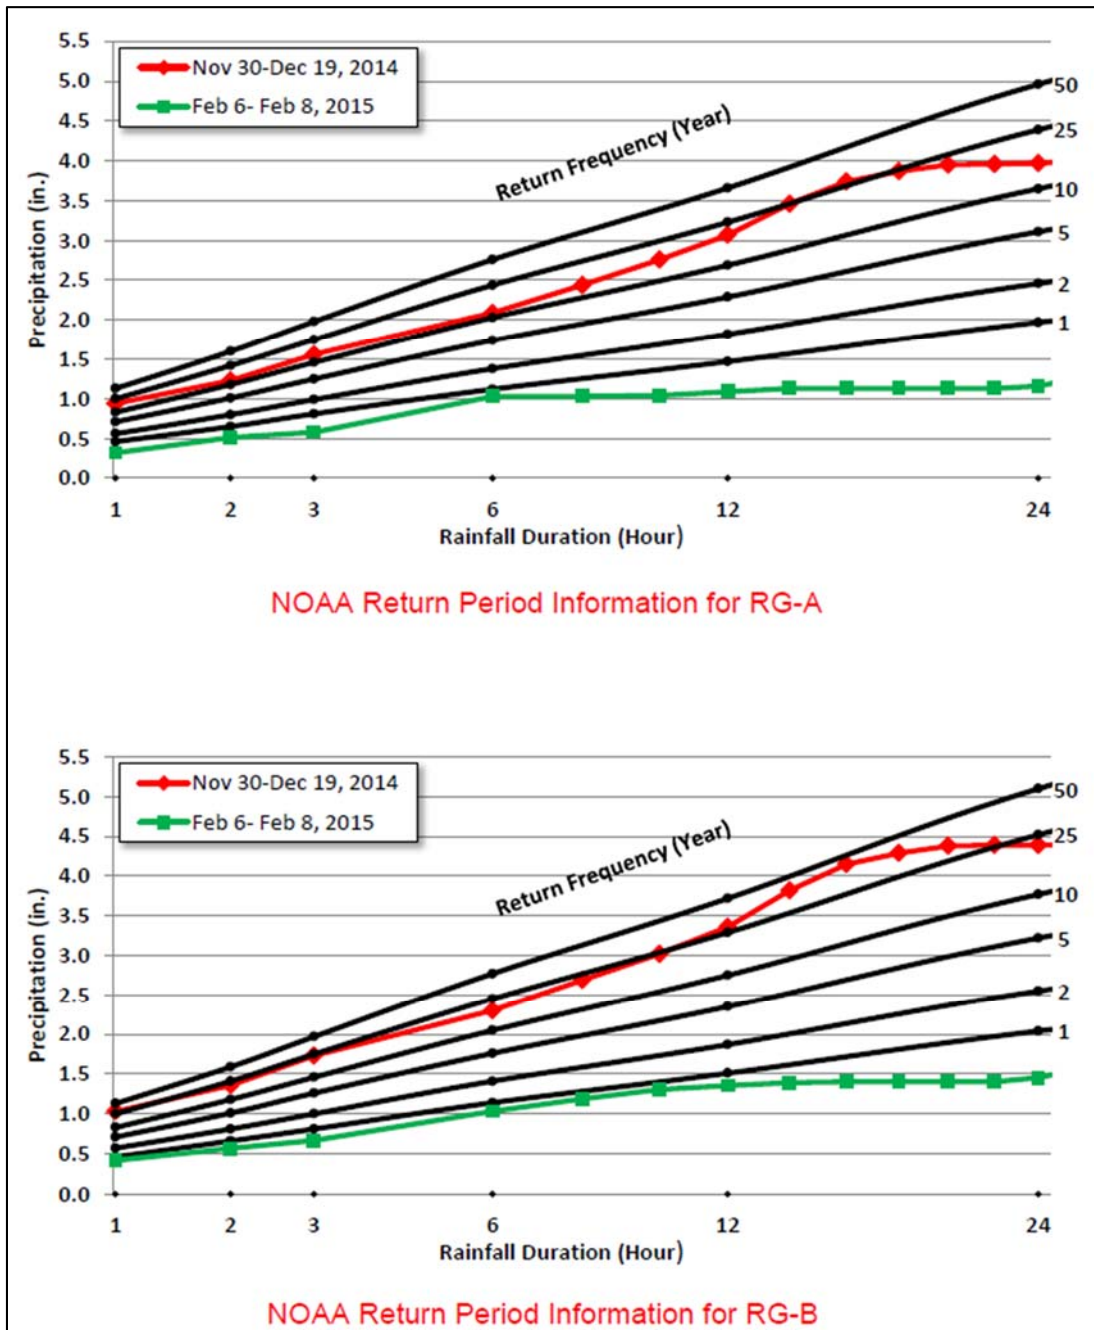
Figure 5. Storm Event Classification at RG-A and RG-B

The monitored storm periods from the 2014/15 monitoring season are compared to historical storm characteristics for the Castro Valley area in Figure 5. As indicated in the figure, the February 3–6, 2015 storm period was not a historically significant event. However, rainfall during the December 11, 2014 storm (shown in the figure as covering the period from November 30 to December 19, 2014) had a return frequency of between 10 and 25 years for rainfall durations of 6-hours to 24 hours.

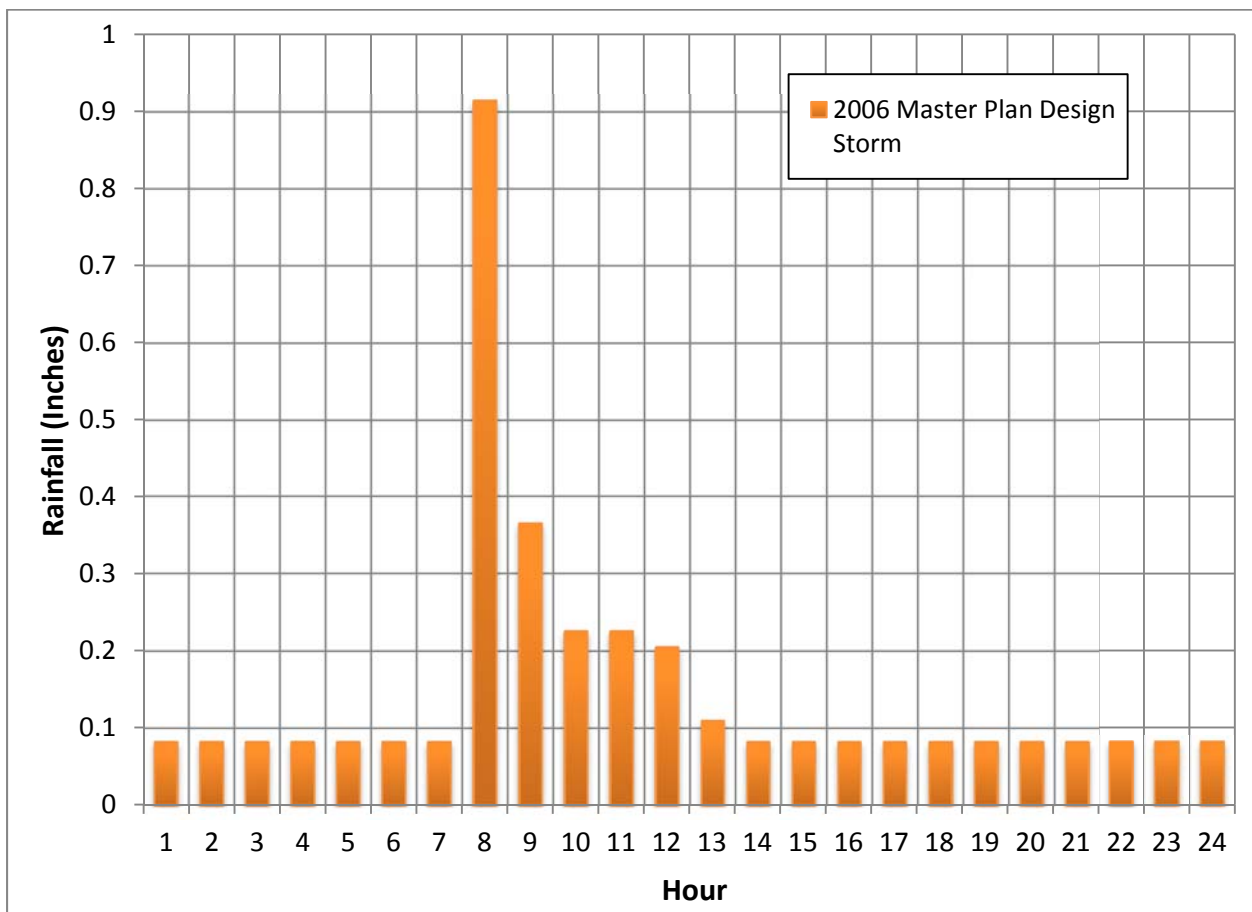
Figure 12. Design Storm Distribution

The design storm used in this analysis is the 10-year, 24-hour storm shown in Figure 12, which is consistent with the design storm used in the 2006 Master Plan.

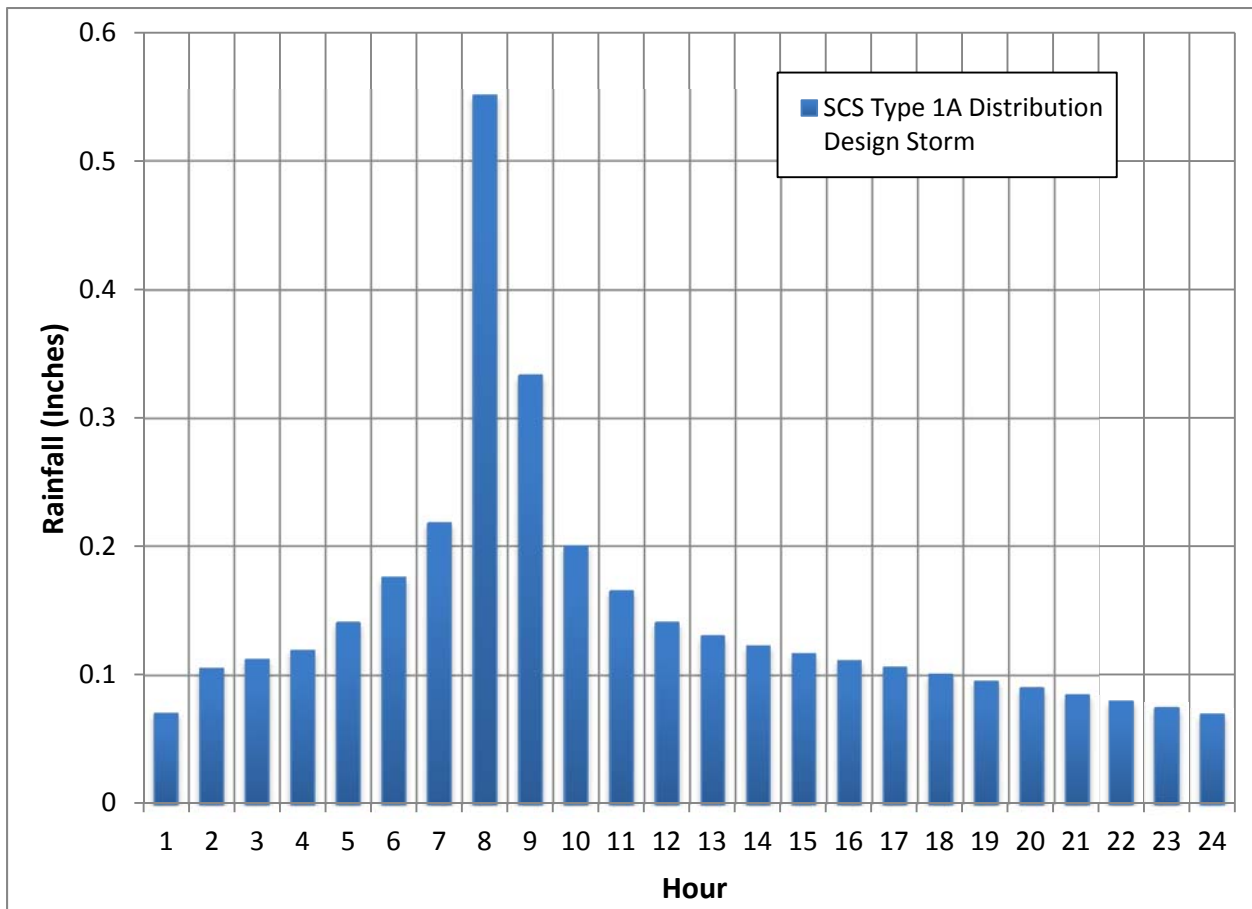
Figure 16. SCS Type 1A Design Storm Distribution

In order to determine how sensitive the CIP projects are to the design storm distribution used, a sensitivity analysis was performed using the 10-year, 24-hour storm defined as the Soil Conservation Service Type 1A storm distribution, as shown in Figure 16. This storm distribution has a less severe peak than the design storm used in this Master Plan Update and in the 2006 Master Plan, but is consistent with the methodologies required under typical San Francisco Baykeeper third-party lawsuits, which is becoming a San Francisco Bay industry standard. It should be noted that both design storm distributions shown in Figure 12 and 16 have equal 10-year, 24-hour rainfall volumes over the 24-hour period - but differ in rainfall distribution over time.

The results of the sensitivity analysis are that while several of the CIP projects would be one or two pipe segments shorter, or of one-size smaller pipe diameter, none of the CIP projects are eliminated by the use of the alternate design storm distribution shown in Figure 16. For the purposes of providing adequate capacity, this minor sensitivity to the design storm distribution was acknowledged by CVSan, but capacity will be provided for the design storm distribution shown in Figure 12, which is slightly more conservative, but very similar in peak to the actual storm metered on December 12, 2015.

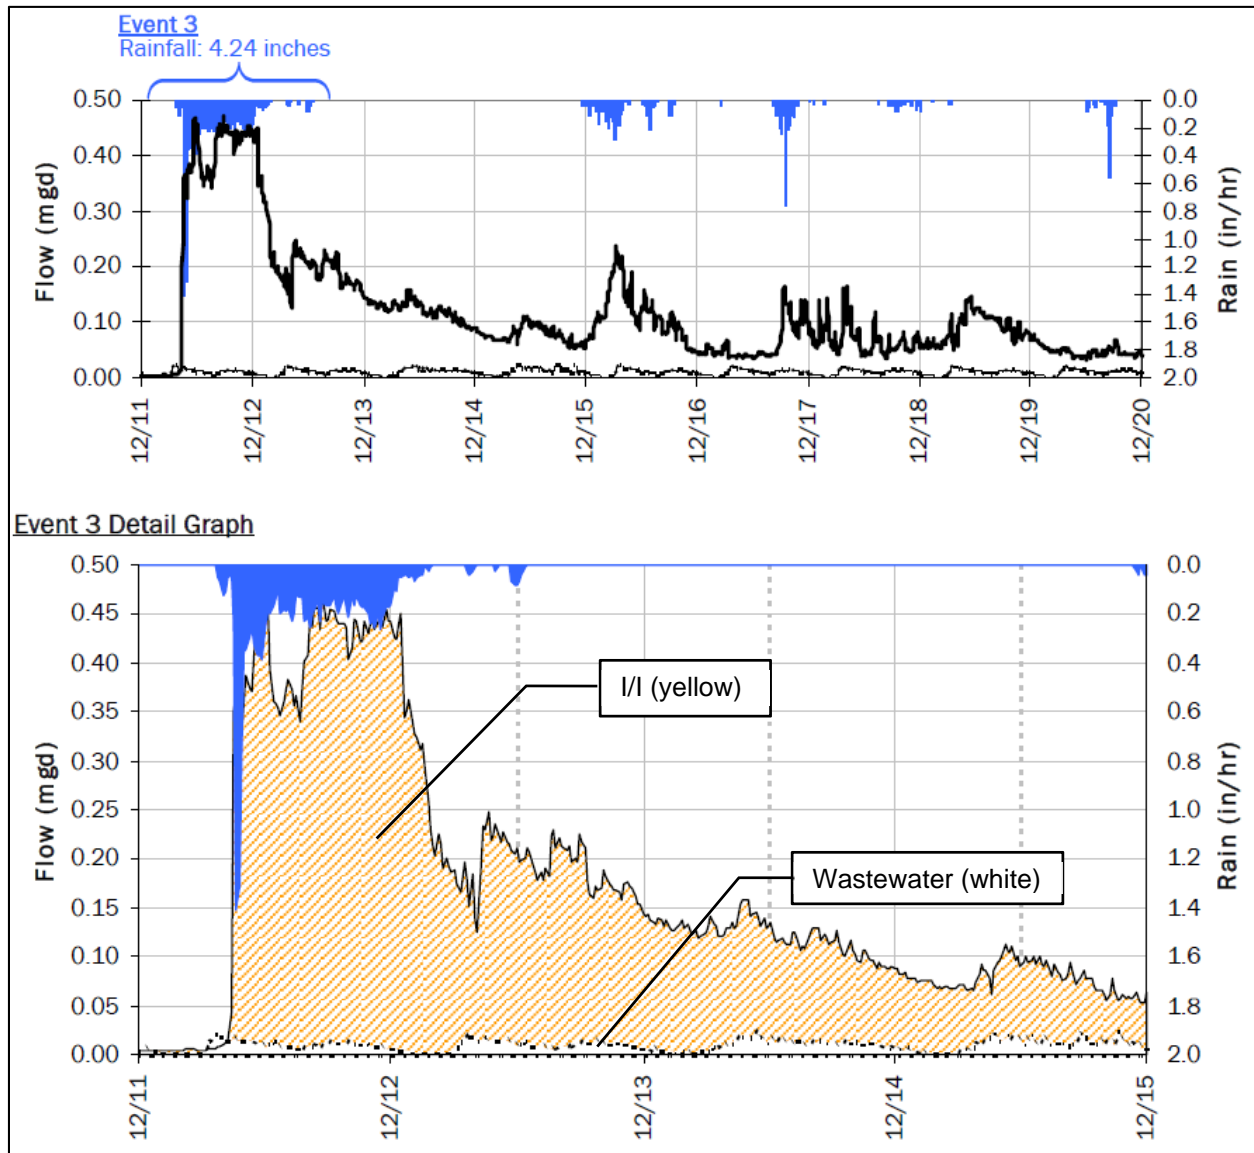
Figure 18. I/I Identified by Sub-basin Flow Monitoring at M-3W

As shown in Table 4, metered flows from M-3W revealed that for a small tributary area, flows increased 50-times during wet weather – producing 0.46 in I/I from this small area, indicating the presence of a significant I/I source (see Figure 18).

In a tributary area this small, it is highly unlikely that this magnitude of I/I is coming simply from deteriorated sewer mains or laterals. Rather, it is likely that there is a direct creek or storm drain inflow source or potentially neighborhood-wide downspout connections. It is highly recommended that CVSan conduct smoke testing in Basin 3W in an attempt to identify the source of I/I here so that it can be removed. Appendix F includes a Smoke Testing Work Plan to facilitate these investigations.

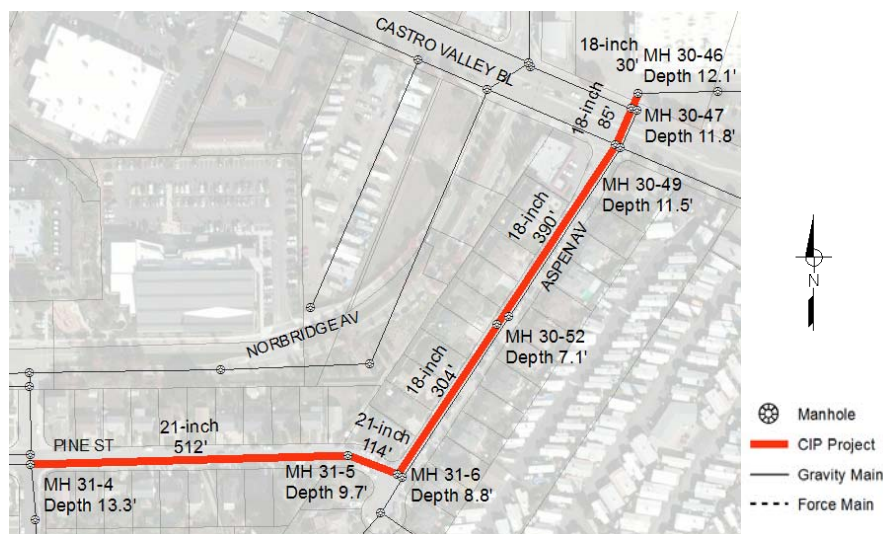
PROJECT LOCATION MAP

- Priority/Fiscal Year:** Priority B: FY 2017/18
- Risk Level:** Medium Risk
- Project Purpose:** Upsize gravity sewer to accommodate PWWF and relieve wet weather surcharging
- Project Location:** Aspen Avenue and Pine Street between Castro Valley Boulevard and Elm Street
- Existing Conditions:**
- 10-inch, 12-inch and 15-inch VCP
 - Existing capacity = 1.17 mgd
 - 2006 ADWF: 0.79 mgd
 - 2015 ADWF: 0.70 mgd
- Design PWWF:** 2.51 mgd (10-year, 24-hour design storm)
- Model Reference:** MH 30-46 to MH 31-4
- Recommendations:**
- Upsize 809 LF of sanitary sewer to 18-inch VCP by open-cut replacement
 - Upsize 626 LF of sanitary sewer to 21-inch VCP by open-cut replacement

ASPEN AND PINE TRUNK SEWER PROJECT SHEET

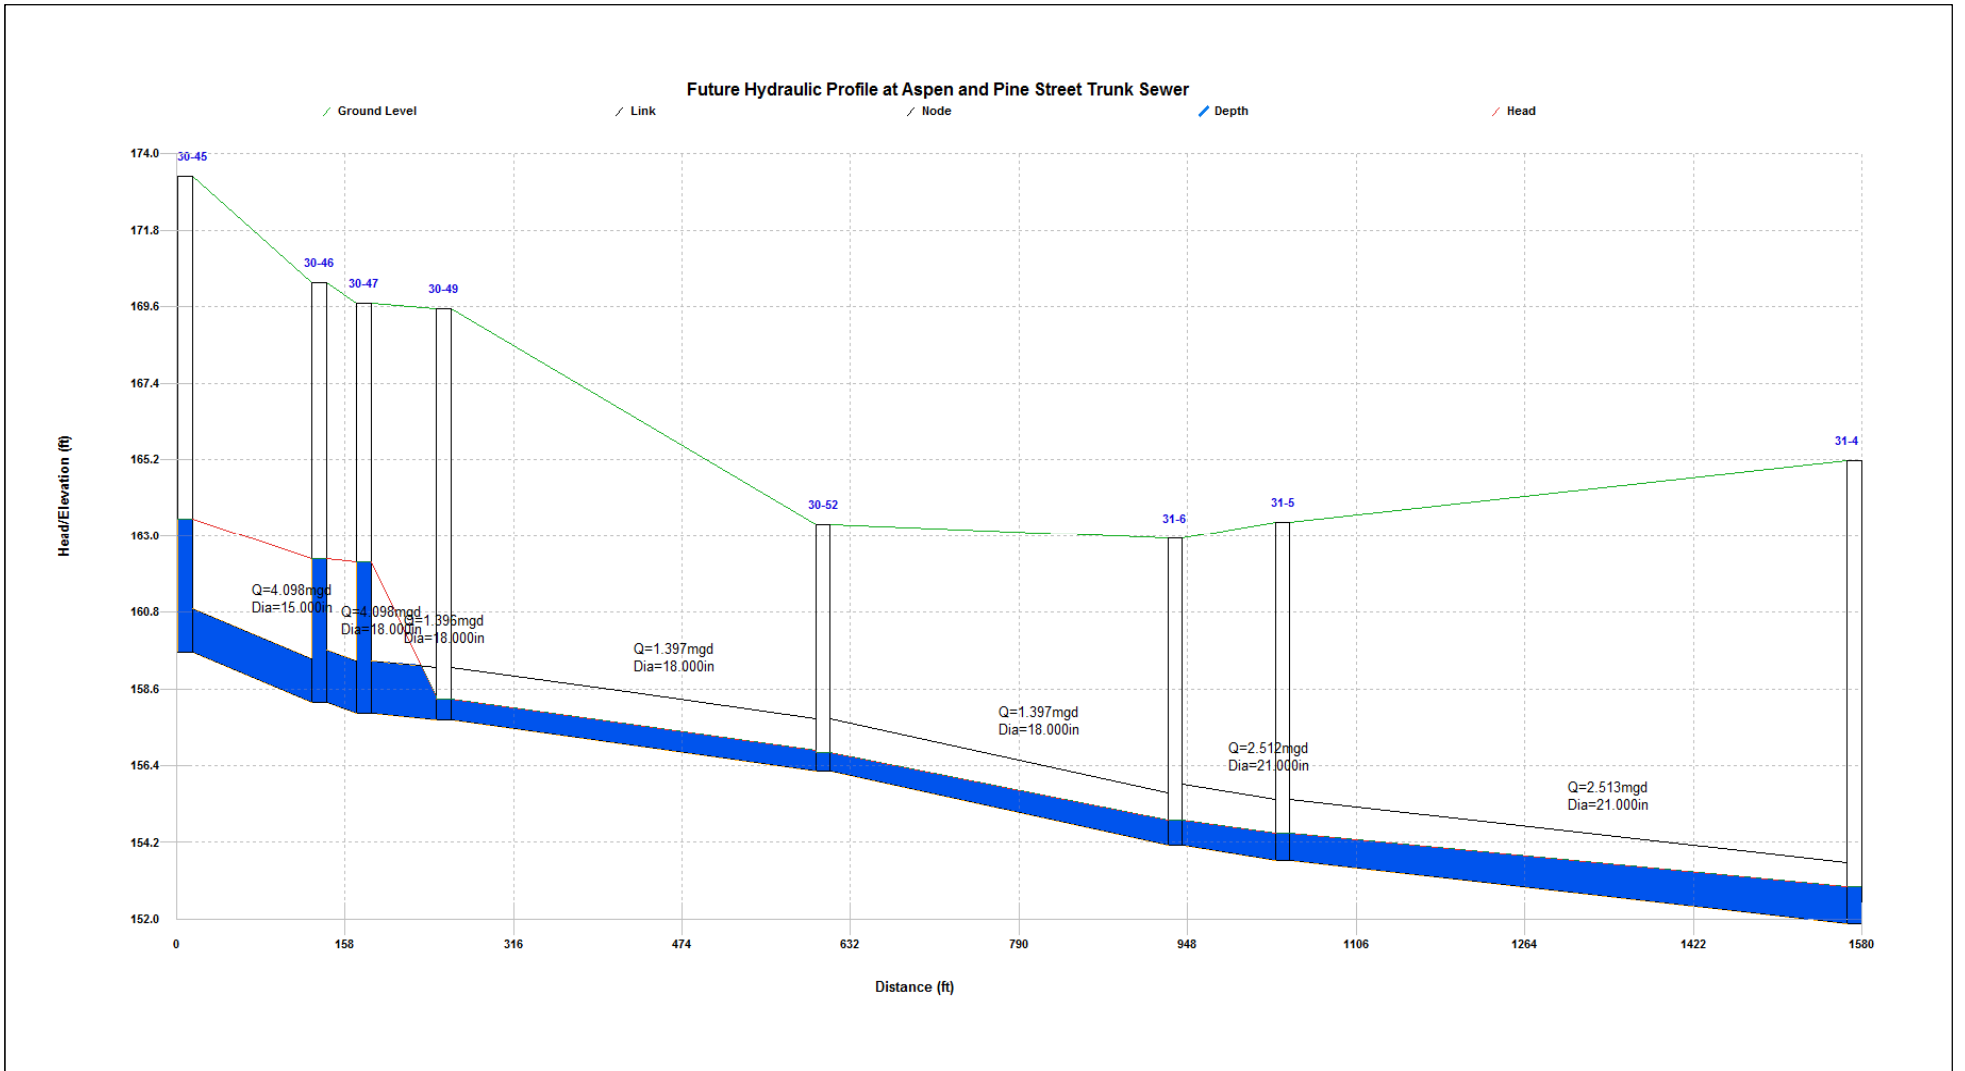
Figure E-9
Future Hydraulic Profile at Aspen and Pine Street Trunk Sewer
 Castro Valley Sanitary District
 WWCS Master Plan Update

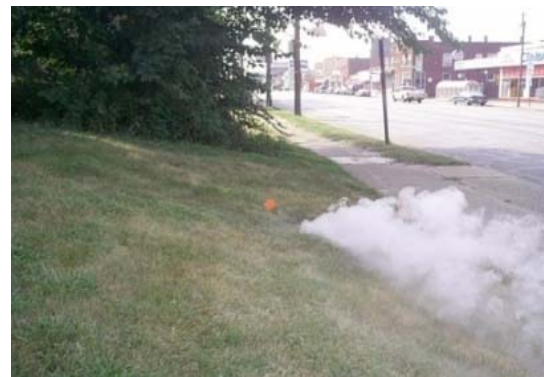
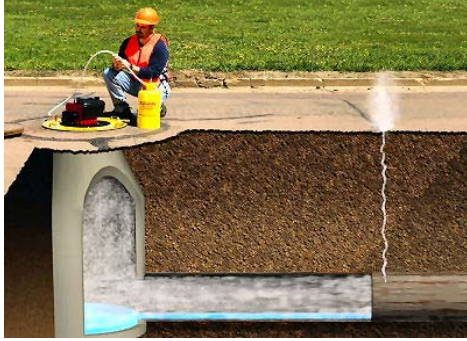
A typical smoke testing system is illustrated here. A large fan or blower is placed over a centrally located manhole pushing non-toxic smoke-filled air through a sewer line. SFE utilizes only industry leading Hurco brand smoke machines and liquid smoke for all projects as it is non-toxic and leaves no residue.

The smoke travels under low pressure and will fill the main line plus any connections; then quickly follows the path of any system defects including cracks and direct cross connections to the ground surface. After placing the blower and filling the lines with smoke, SFE staff will perform a visual inspection of the area being tested. This inspection includes GPS locations of the incidents, photograph documentation, along with standard field incident forms being filled out.

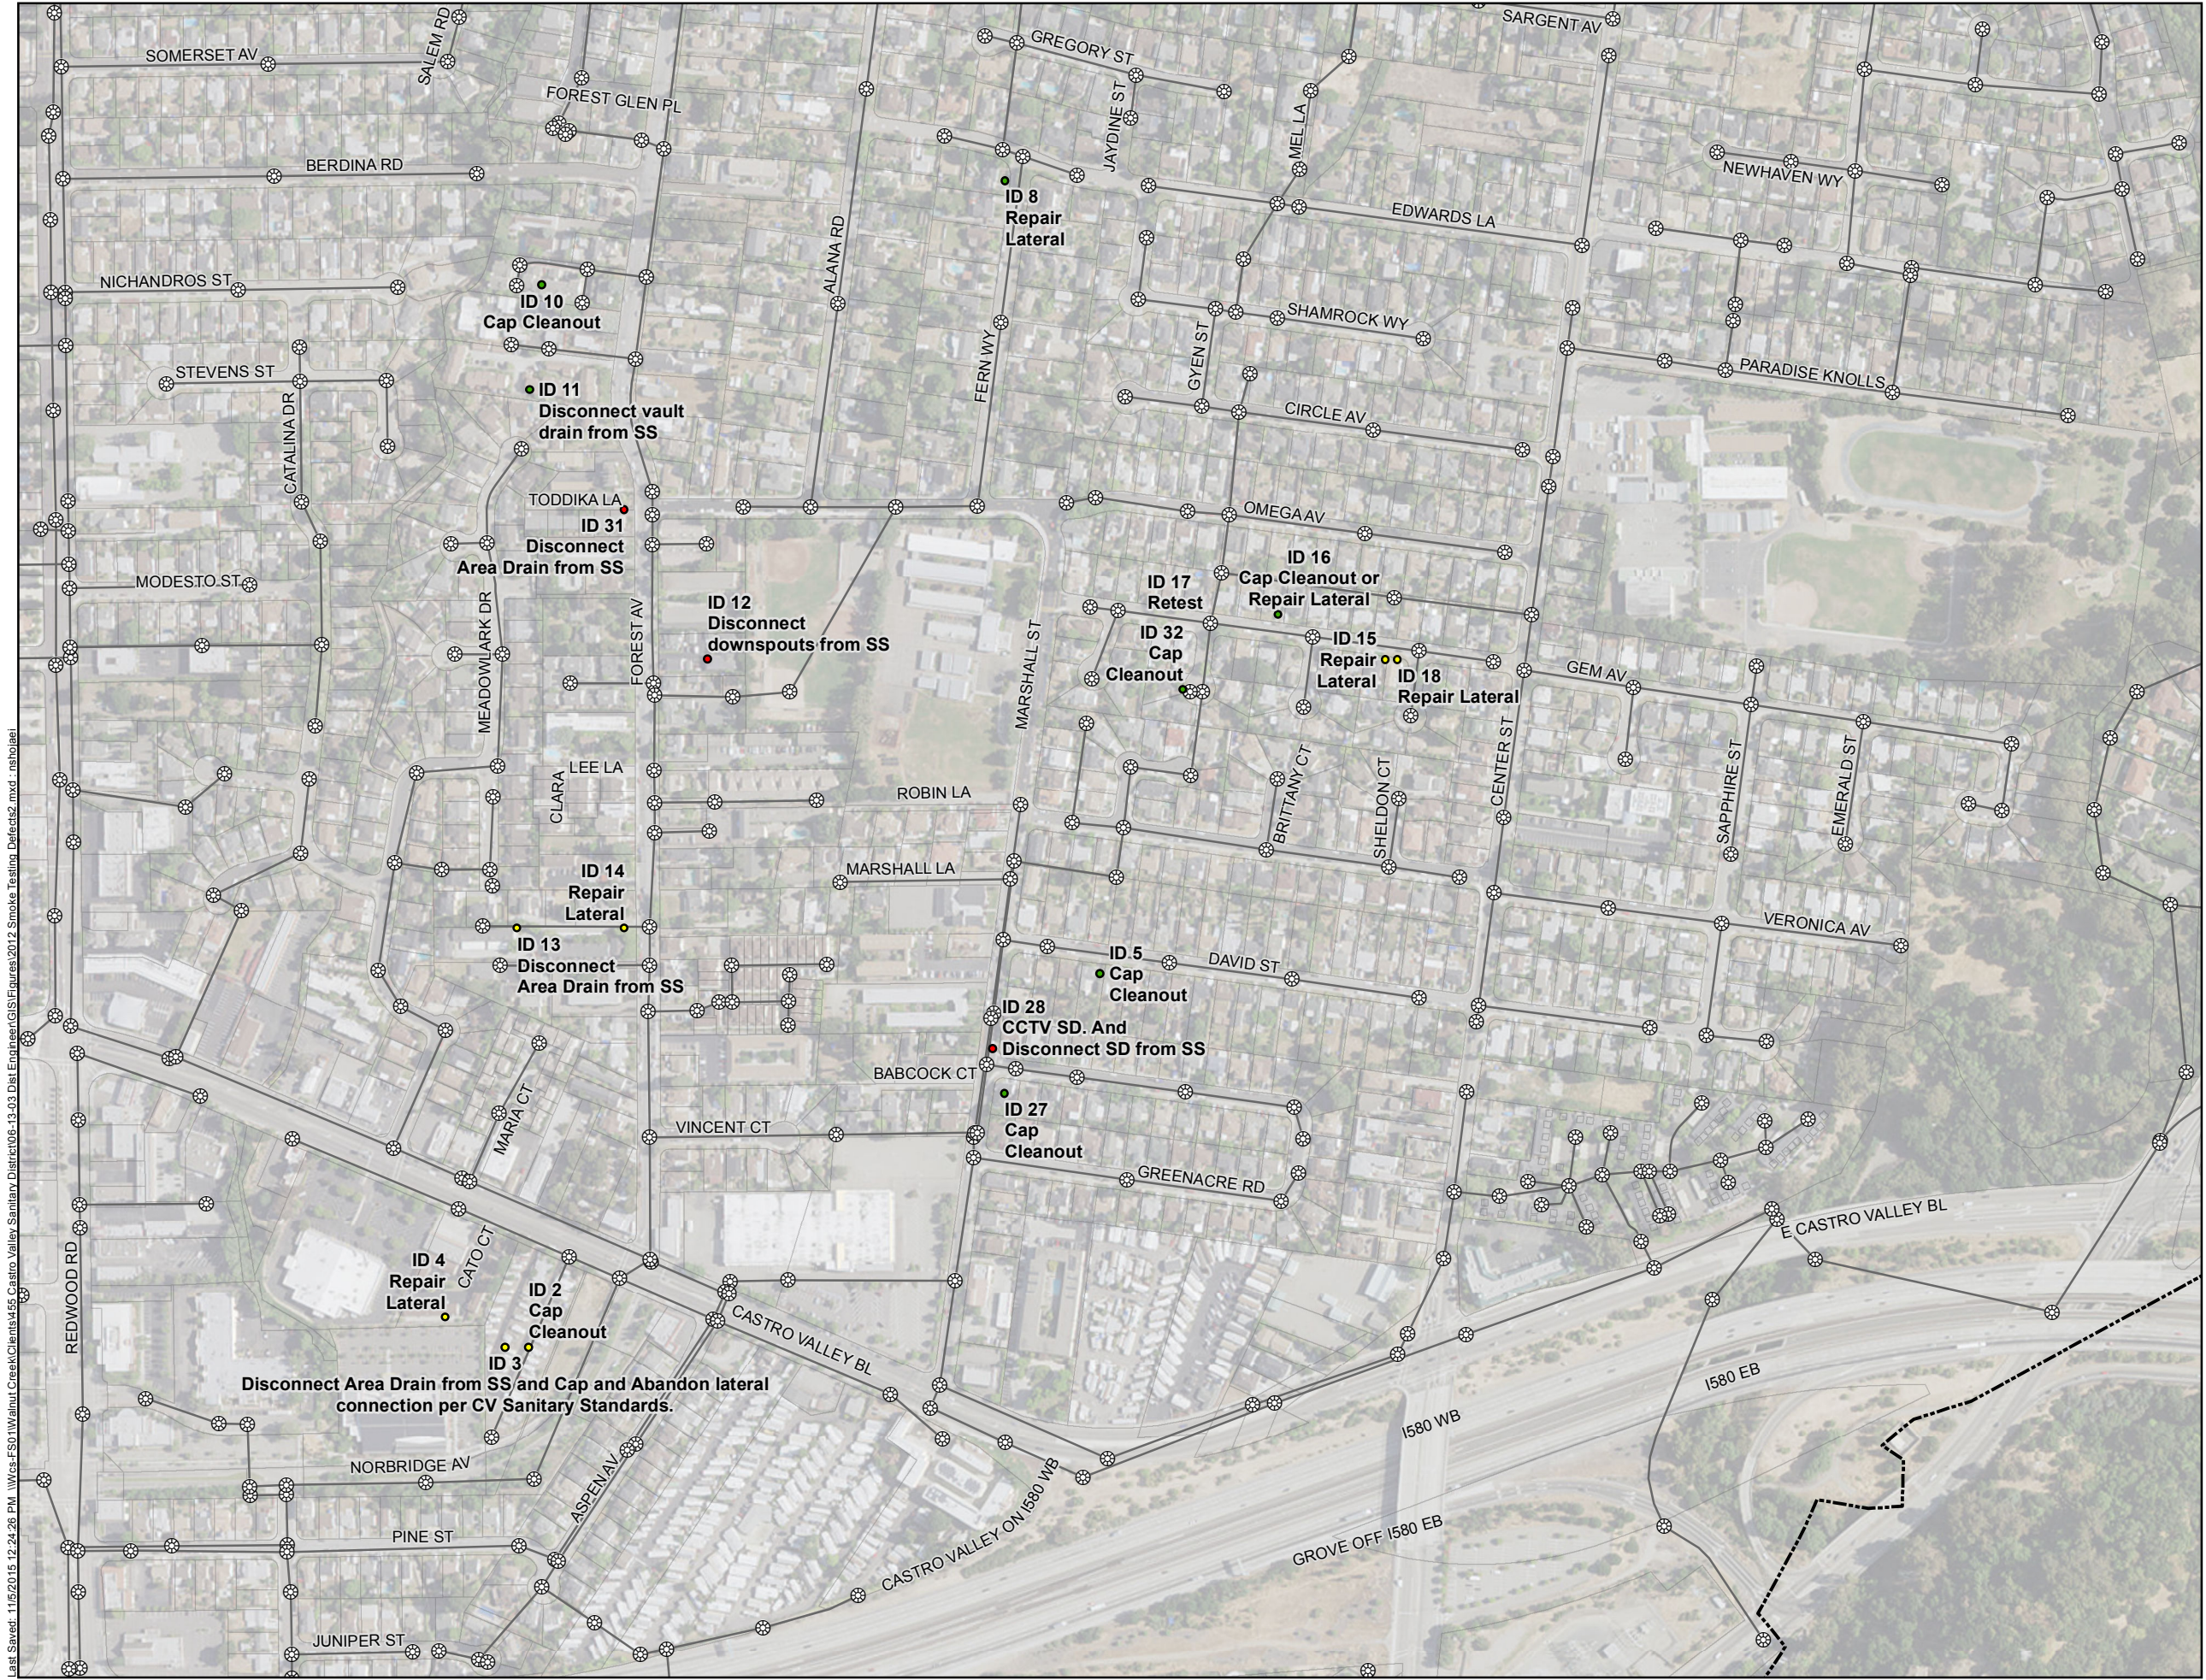
- Symbology**
- 2012 Smoke Testing Defects**
- Light
 - Moderate
 - Severe
 - ⊗ Manhole
 - PS Pump Station
 - Force Main
 - Gravity Main
 - District Boundary

Figure 2
2012 Smoke Testing Defects
 Castro Valley Sanitary District
 Wastewater Collection System
 Master Plan Update
